Home Inspection Report

Sample

Inspected On Tue, Jan 21, 2025 at 12:19 PM

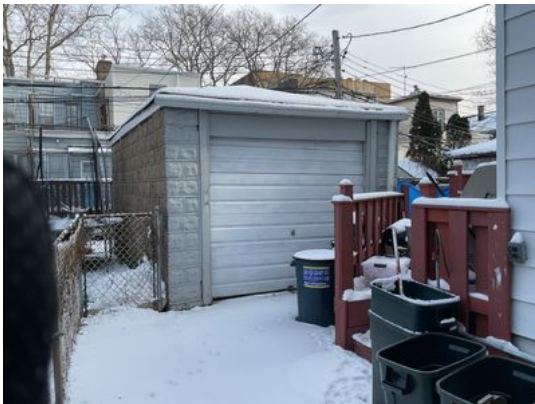
Comment 4 Information

Locked no key available

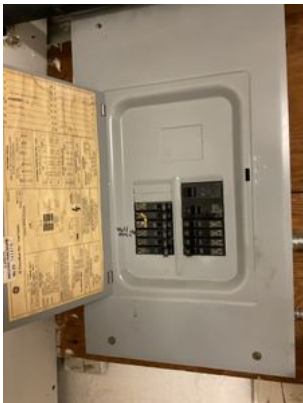
Photo of Panel

Condition: Repair or Replace

Comment 8**Safety Concern**

Panel not marked .if someone needs to service no way of knowing which breaker serves what outlet
